Power System Operating Incident Report – Trip of Three 500 kV Circuit Breakers at Hazelwood Terminal Station on 7 February 2014

PREPARED BY: Systems Capability

DATE: 24 April 2014

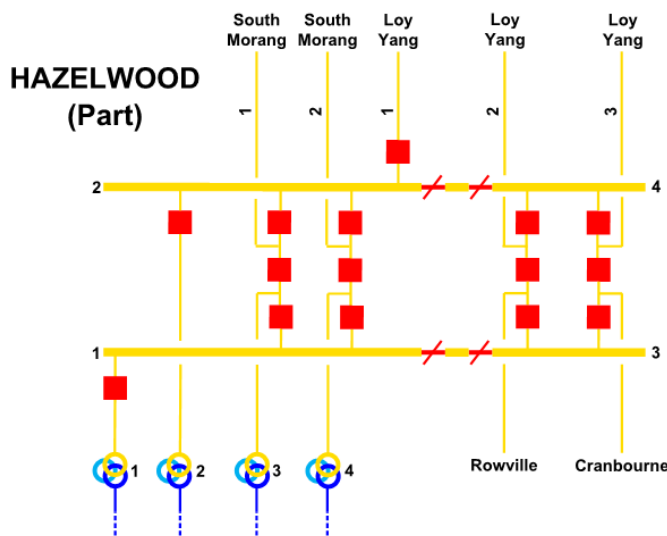
Figure 1 - Status of the power system prior to the incident

The status of the power system prior to the incident is shown in Figure 1 and after the incident in Figure 2. For clarity only equipment relevant to this incident has been included in the diagrams. Figure 2 shows the 500 kV CBs that opened as a result of this incident.

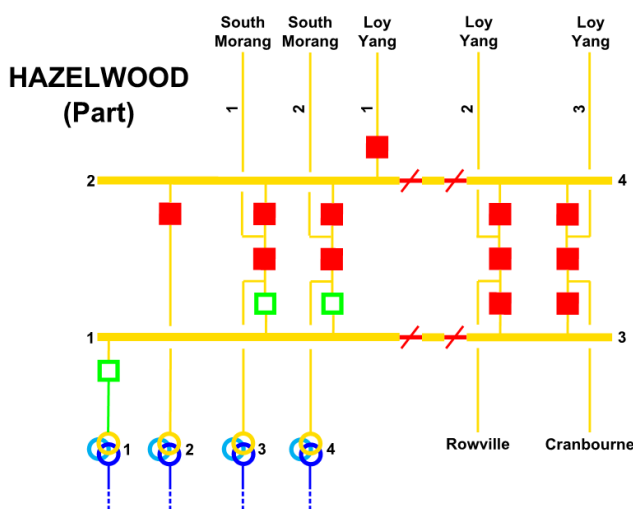
Figure 2 - Status of the power system immediately after the incident

On Friday 7 February 2014, at 1030 hrs, the following 500 kV circuit breakers (CBs) tripped at Hazelwood Terminal Station:

- Hazelwood No.1 Transformer - this resulted in the offloading of No.1 500/220 kV Transformer
- Hazelwood No.3 Transformer No 1 500kV Busbar
- Hazelwood No.4 Transformer No 1 500kV Busbar

SP AusNet determined that the No.1 500kV Busbar was still energized (therefore no fault present). At 1038 hrs SP AusNet closed the Hazelwood No.1 Transformer 500kV CB, which then returned No.1 Transformer to service, and then closed the two remaining open CBs.
