Trip of Torrens Island Units B3 and B4 on 14 July 2014

AN AEMO POWER SYSTEM OPERATING INCIDENT REPORT FOR THE NATIONAL ELECTRICITY MARKET

PUBLISHED NOVEMBER 2014

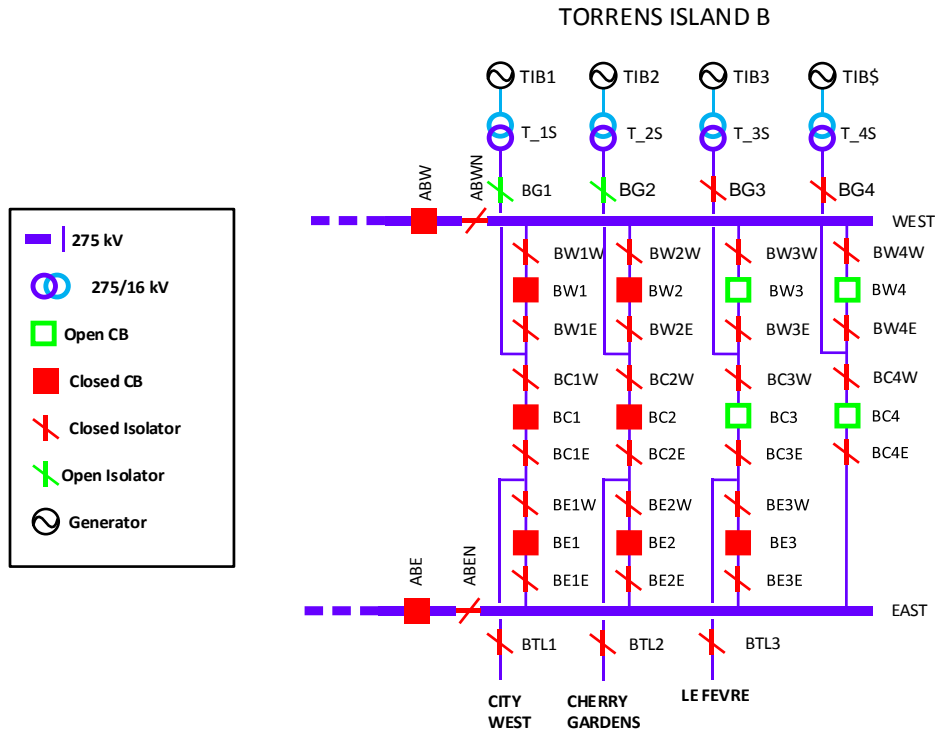
Diagram illustrating the power system at Torrens Island B substation after the incident. Circuit breakers BW3, BW4, BC3, and BC4 opened as a result of the incident.

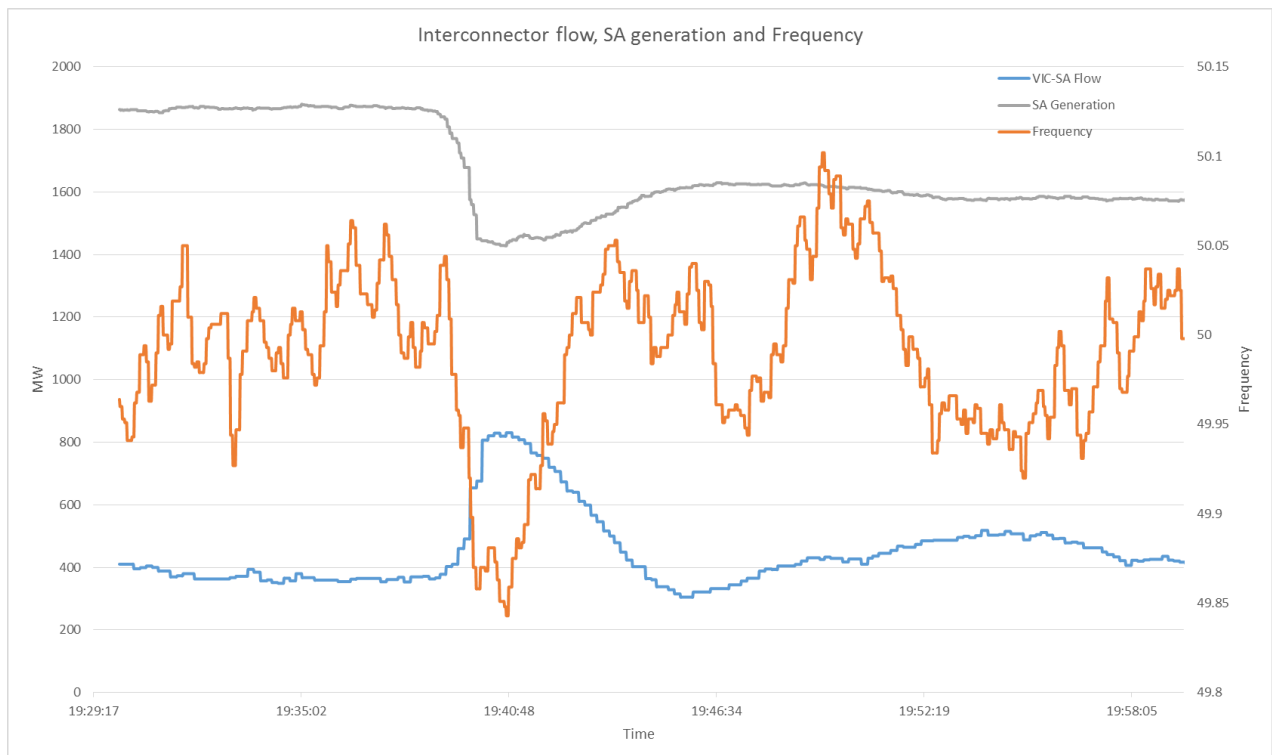
1. As a result of the incident, the VIC-SA interconnector satisfactory limit was exceeded for approximately 4.5 minutes. This means the power system was not in a satisfactory operating state during this period. Power system frequency fell during this period but remained within the frequency operating standard. The power system returned to a satisfactory operating state after 4.5 minutes due to generation response and frequency relief, and to secure operating state during the following dispatch period.

Graph showing frequency, the VIC_SA interconnector flow and generation in South Australia
