OFFLOADING OF ROTS– SMTS–KTS 500 KV LINES ON 1 SEPTEMBER 2017

REVIEWABLE OPERATING INCIDENT REPORT UNDER THE
NATIONAL ELECTRICITY RULES

Published: **November 2017**

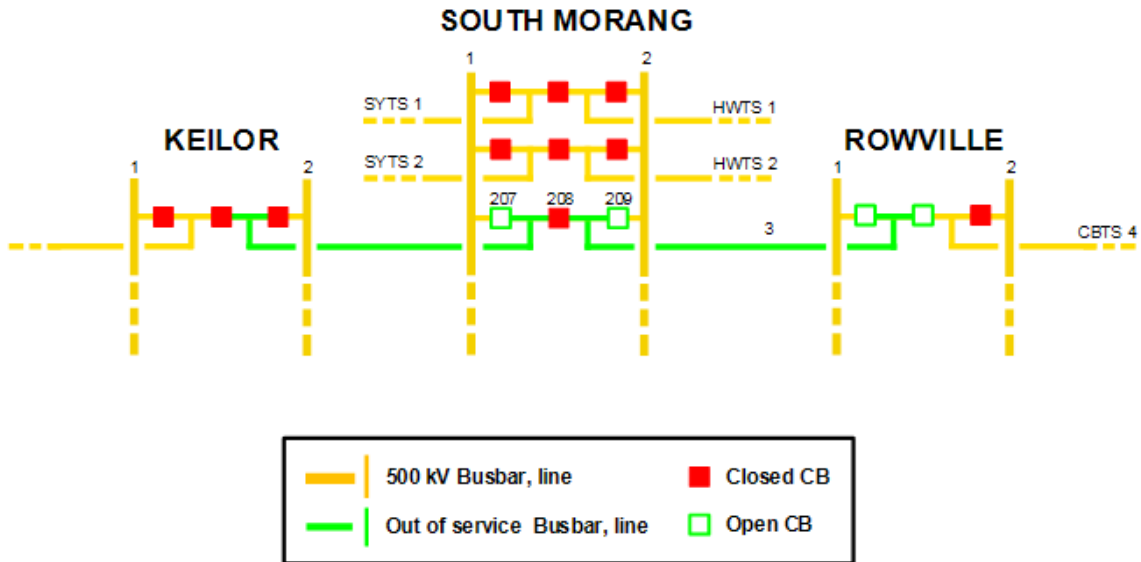
APPENDIX A. POWER SYSTEM DIAGRAM

During this incident, the ROTS-SMTS-KTS 500kV lines remained energised from KTS end only. No load or generation was lost as a result of this incident. Both SMTS-ROTS No3 500kV line and SMTS-KTS 500kV line were returned to service by 1307 hrs on 1 September. Appendix A indicates the relevant section of the power system diagram illustrating the incident.

Since the SMTS–KTS 500 kV line remained in service and on-load, the shorting out of the current inputs at SMTS created an imbalance between the currents in the relays at two ends of the line (SMTS and KTS), resulting in the operation of the ‘Y’ current differential protection on the line. Operation of the ‘Y’ protection resulted in both direct and CB Fail⁷ trip signals being sent to the associated CBs at SMTS, KTS and ROTS.

No CBs were tripped at KTS, because both the main and CB Fail trips had been correctly isolated earlier in the morning as part of isolation of the Y protection relay. However, although the main trips at SMTS had been correctly isolated, the CB Fail trip links at SMTS were not included in the isolations carried out earlier. As a consequence, the CB Fail timers timed out after 100 ms, and CB Fail commands were initiated to both the CBs between:

This figure shows the relevant section of the power system immediately after the incident

While the initial isolations carried out to remove a faulty relay from the service were considered suitable for this work, additional isolation should have been done prior to relay testing when the replacement relay was being commissioned.

The procedures relating to isolation requirements during the initial fault investigation and the follow-up repair work have been re-iterated to all AusNet field staff.
